HO-1009

6224 Hanover Road Private

Maryland Historical Trust Maryland Inventory of Historic Properties Form

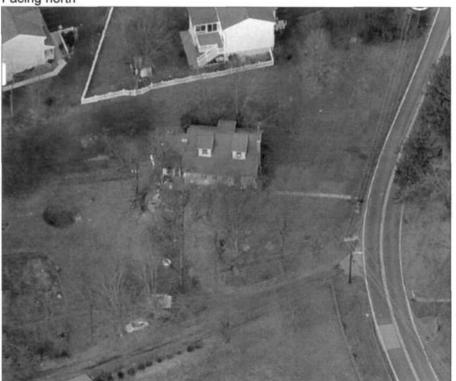
Maryland Historical Trust DHCD/DHCP 100 Community Place Crownsville, MD 21032-2023 410-514-7600 HO-1009 6224 Hanover Road, site Bing Maps Bird's Eye image, c. 2010 Facing north

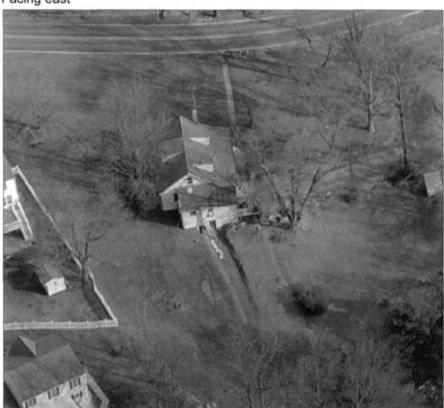
Facing east

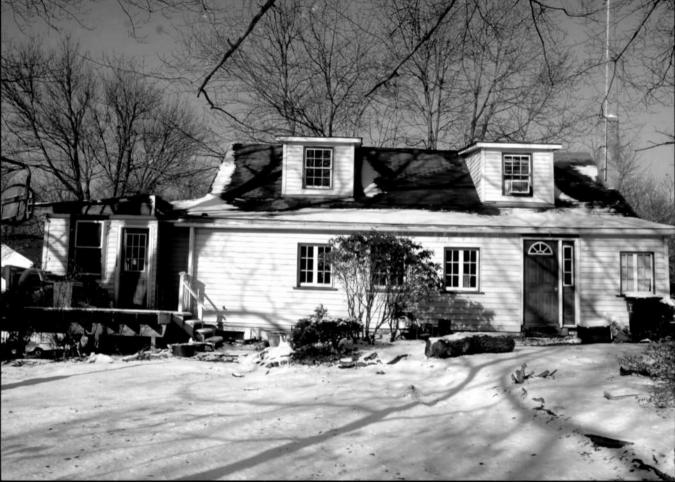
HO-1009_2010-01-08_01 South elevation

40-1009 6224 Harrover Read Howard County, 1911 Ken Short Jan. 8, 2010 MD SHPO South elevation

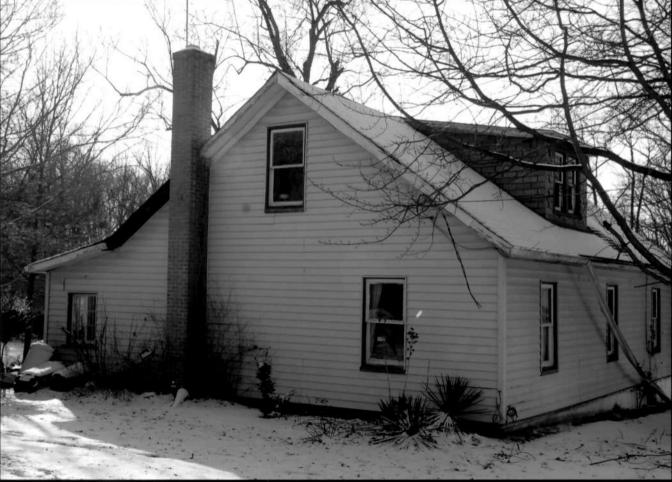
HO-1009_2010-01-08_02 East & north elevations

40-1009 6224 Hancver Road Howard County, 11D Ken Short, Jan 8 . 2010 MDSHPO East & North Elevations 2/2
